# RIZQ VEHICLE INSPECTION

Pre-Purchase Inspection Report | 250-Point Inspection System

Report ID  
**3825-MN**

| Year / Make / Model | 2024 Hyundai Santa Fe Hybrid Calligraphy AWD |

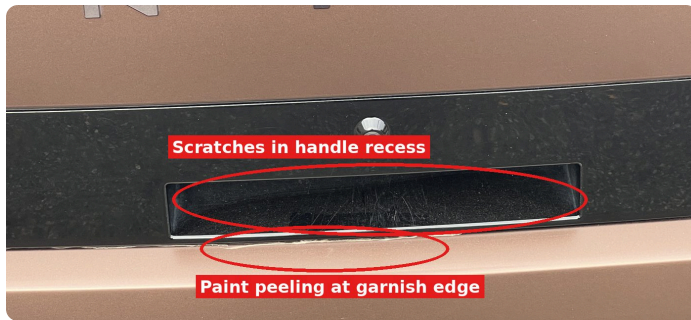
| Liftgate | <b>Paint peeling</b> along the bottom edge of the gloss black garnish under the handle recess; heavy scratches inside the handle recess. Rear camera lens intact. |

Liftgate: paint peeling at the garnish edge, scratches in the handle recess

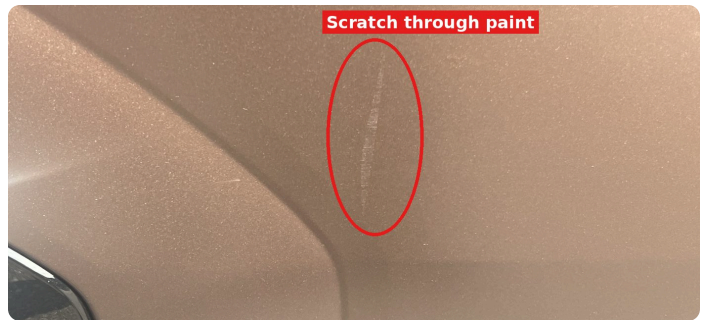
| Right rear door | <b>Scratch through the paint</b> at the lower rear corner above the wheel arch, with a smaller scuff on the body line next to the flare. |

Right rear door: scratch through the paint

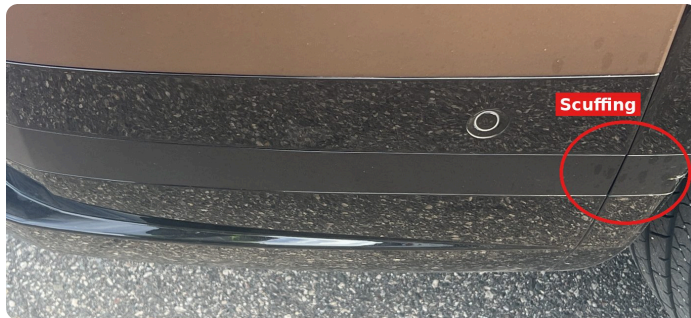
| Rear bumper | <b>Scuffing</b> on the lower gloss black and matte strips at both corners near the parking sensors. |

Rear bumper corner: scuffing

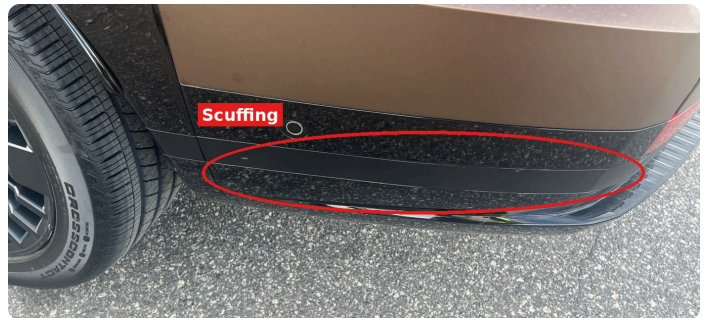
Rear bumper lower strip: scuffing

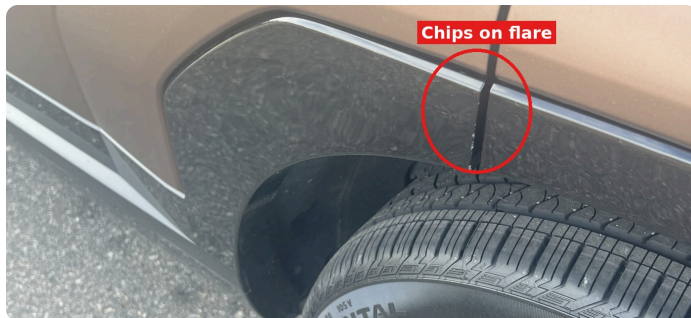
| Rear wheel arch flare | Small chips in the gloss black flare at the rear door seam. |

Rear wheel arch flare: chips

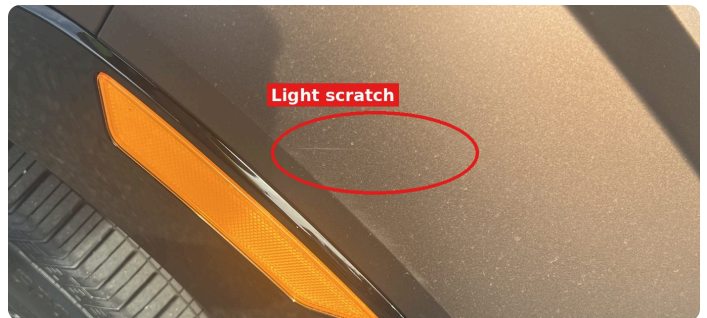
| Left front fender | Light scratch in the paint behind the side reflector. |

Left front fender: light scratch

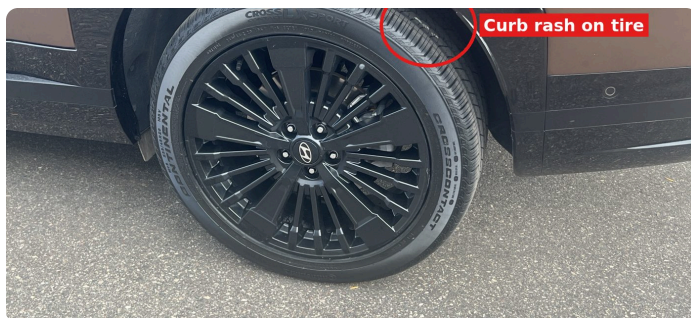
| Left rear tire | <b>Curb rash</b> on the outer tread shoulder. Surface only. |

Left rear tire: curb rash

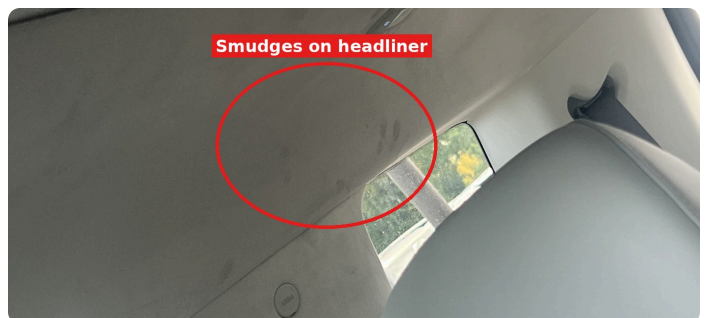
| Headliner | Smudges and hand marks above the 2nd row, mostly passenger side. Cleans up with detailing. |

Headliner: smudges

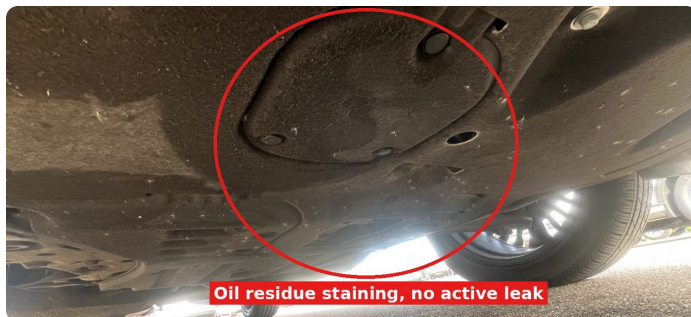
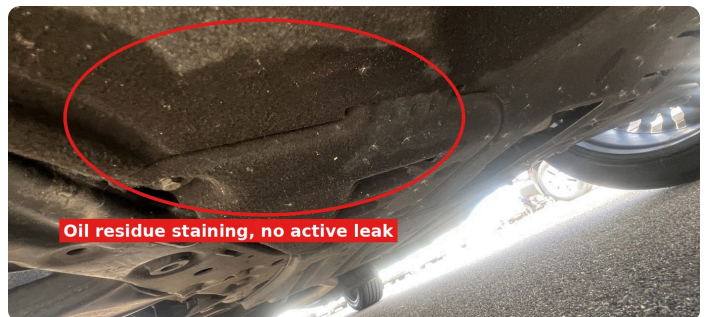
Underneath, there is an oil stain on the underbody cover. It does not look like an active oil leak: no fresh oil, drips or wet areas were found on the engine, transmission or underbody at the time of inspection. It appears to be residue left over from prior service.

Underbody shield: oil residue staining, no active leak

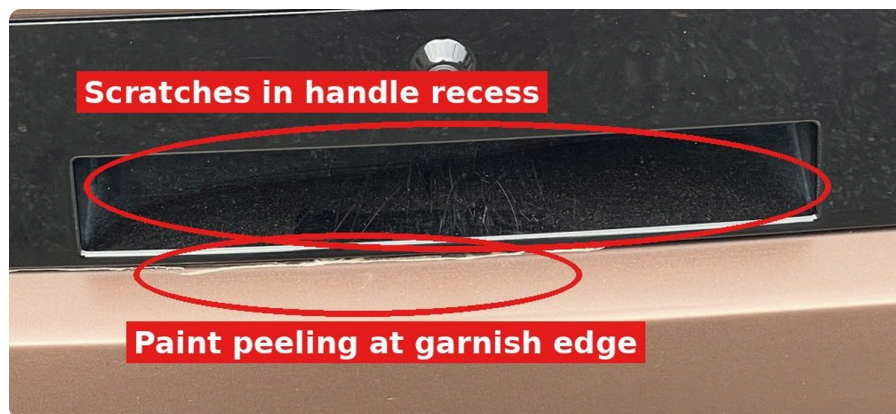
Liftgate garnish: paint peeling along the bottom edge and scratches inside the handle recess

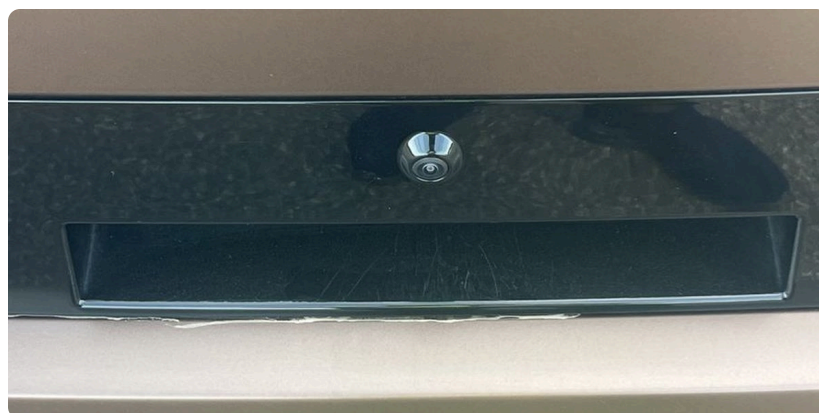
Liftgate garnish, second angle: scratches across the handle recess and peeling at the lower edge

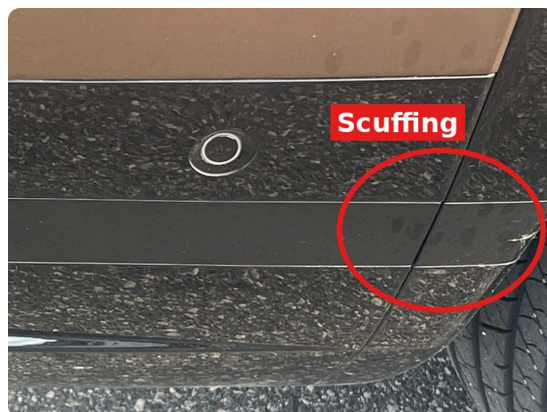
Rear bumper corner: scuffing on the lower gloss black and matte strips near the tire

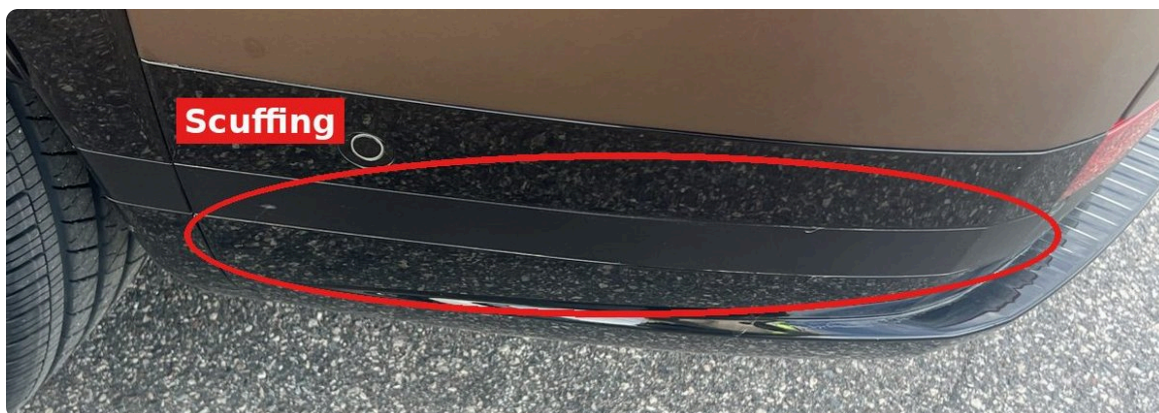
Rear bumper lower strip, opposite corner: scuffing along the matte strip

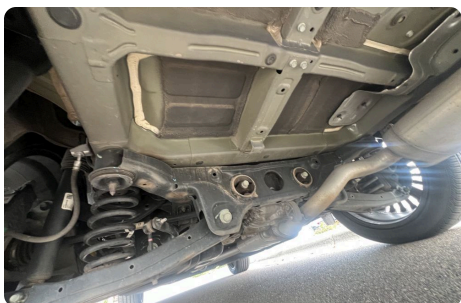
Rear subframe

Frame rails, rear subframe, crossmembers and floor pan inspected. No frame damage, kinks or welds. Light surface rust on the rear subframe and control arm hardware, normal for a Minnesota vehicle and not structural. No scaling or perforation.

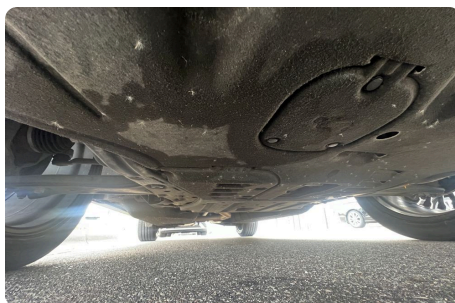
Underbody shield

| Undercarriage | All underbody shields in place. CV boots, steering rack boots, tie rods and sway bar links good. Exhaust and muffler intact. Light surface rust on the rear subframe, normal for the region. Oil residue staining on the underbody shields, likely left over from prior service. No active oil leak found; shields and engine dry at the time of inspection. |
