# RIZQ VEHICLE INSPECTION

PRE-PURCHASE INSPECTION REPORT · 250-POINT INSPECTION

Report ID: **4415-TN**

| Year / Make / Model | 2013 Nissan Frontier | Body | King Cab, 6 ft Bed |

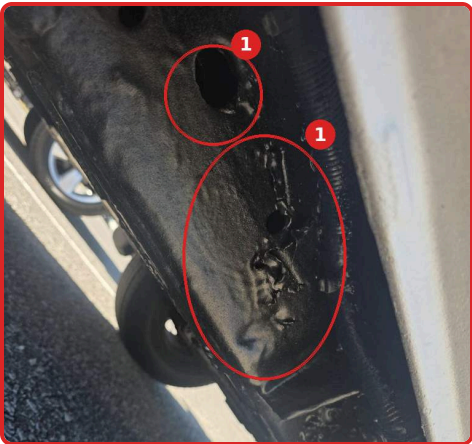
| Item | Status | Notes |
|---|---|---|
| Frame rails | Poor | Rust perforation with scaled, jagged hole edges. Fresh black undercoating sprayed over the pitted metal (#1). |

You asked us to check the frame rails for rust or repairs hidden under fresh paint. The frame has rust perforation, and fresh undercoating has been sprayed over the corroded metal. This is the main reason for the Walk Away verdict.

#1 Frame rail: pitted, perforated metal sprayed over with fresh black undercoating

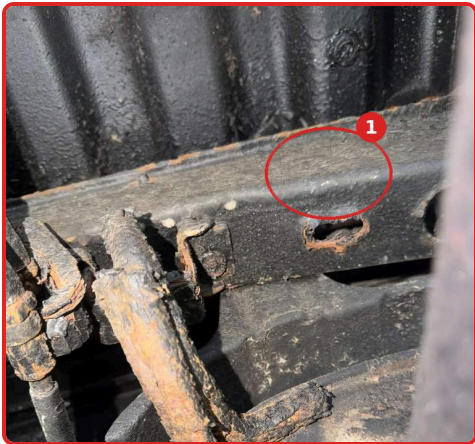
#1 Frame rail rusted through with jagged, scaled hole edges

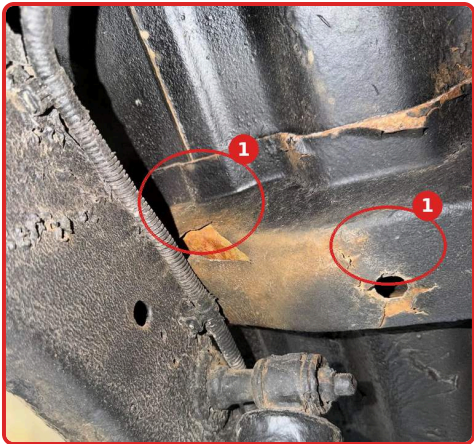
| Item | Status | Notes |
|---|---|---|
| Crossmember / floor supports | Poor | Rust-through holes and flaking metal (#1). |

#1 Crossmember / floor support: rust perforation and flaking metal

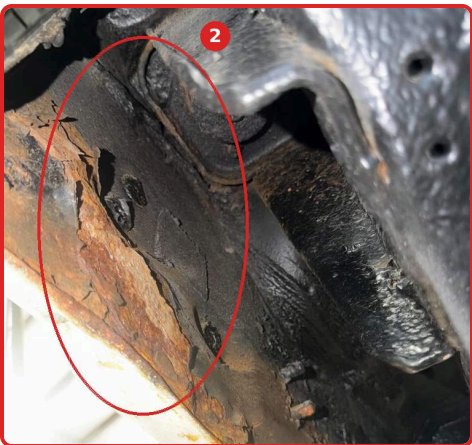
| Item | Status | Notes |
|---|---|---|
| Rockers / seams | Poor | Heavy layered rust along the rocker pinch seam; seams lifting the undercoat (#2). |

#2 Rocker pinch seam: heavy layered rust and delamination

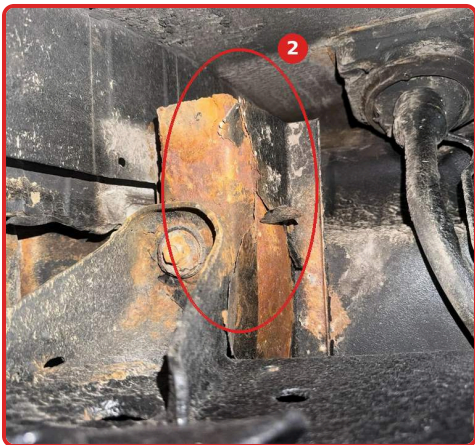
| Item | Status | Notes |
|---|---|---|
| Body mounts | Poor | Cab mount bracket is heavily scaled and delaminating (#2). |

#2 Cab mount bracket: heavy scaling and delaminating metal

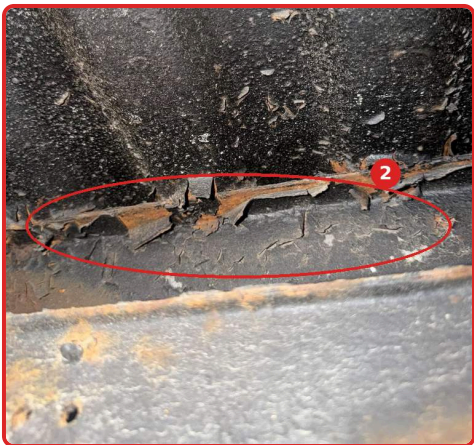
#2 Underbody seam: rust lifting the undercoating

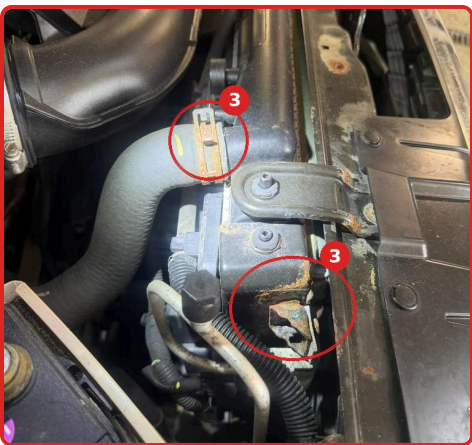
| Item | Status | Notes |
|---|---|---|
| Cooling system | Attention | Coolant full and clean. Radiator core support is rusted and torn near the lower mount (#3). |

#3 Core support rusted and torn at the lower mount; hose clamp corroded

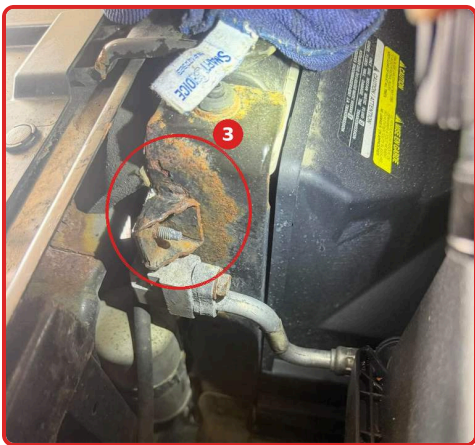
#3 Core support area: heavy rust scale and lifting metal

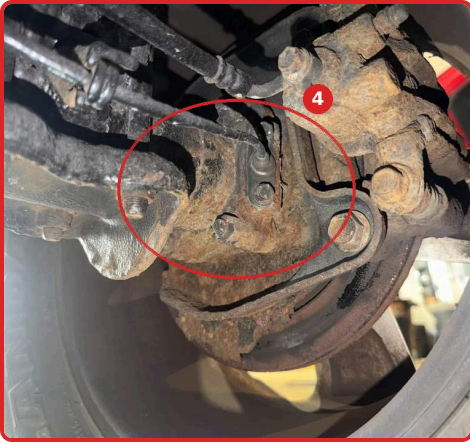
| Item | Status | Notes |
|---|---|---|
| Outer tie rod ends | Poor | Both are worn out. Replace and align (#4). |
| Knuckles / hubs | Attention | Heavy rust scaling (#4). |

#4 Knuckle and outer tie rod: heavy scaling; both outer tie rods worn out

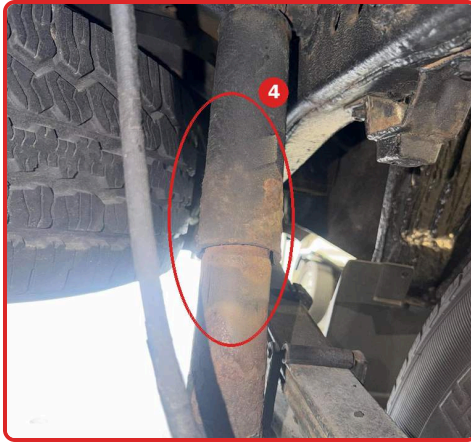
| Item | Status | Notes |
|---|---|---|
| Rear shocks | Attention | Heavily corroded bodies (#4). |

#4 Rear shock absorber: heavily corroded body

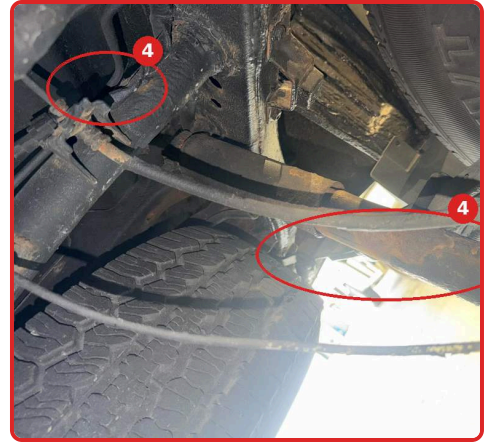
| Item | Status | Notes |
|---|---|---|
| Leaf springs | Attention | Rust on the springs and hangers (#4). |

#4 Leaf spring hanger and brake lines: corrosion

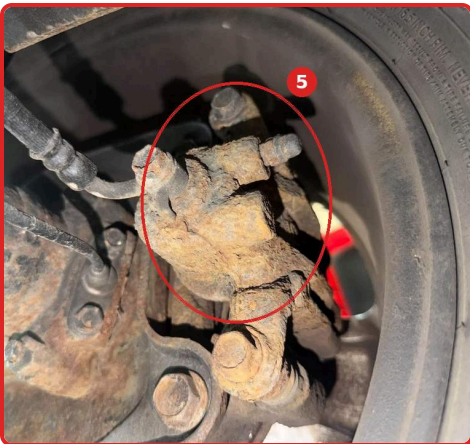
| Item | Status | Notes |
|---|---|---|
| Calipers | Poor | All four calipers are heavily rusted, to the point a piston could seize at any time (#5). |

#5 Brake caliper heavily rusted; piston could seize at any time

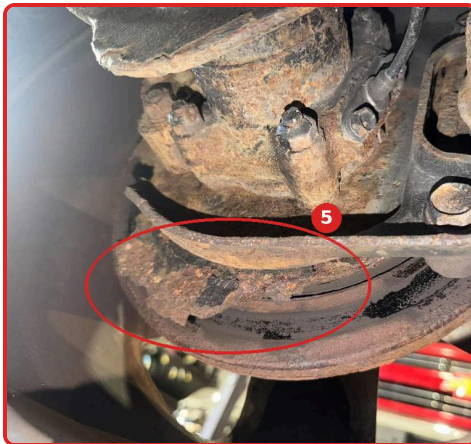
| Item | Status | Notes |
|---|---|---|
| Rotors / dust shields | Attention | Rotor edges rusted. Front dust shield rusted through and separating (#5). |

#5 Front dust shield rusted through and separating; rotor edge rusted

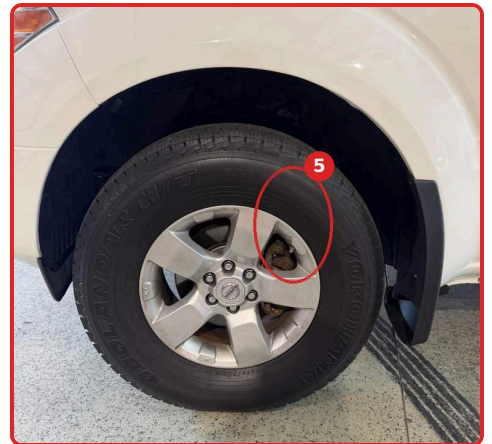
#5 Front caliper seen through the wheel: heavy rust

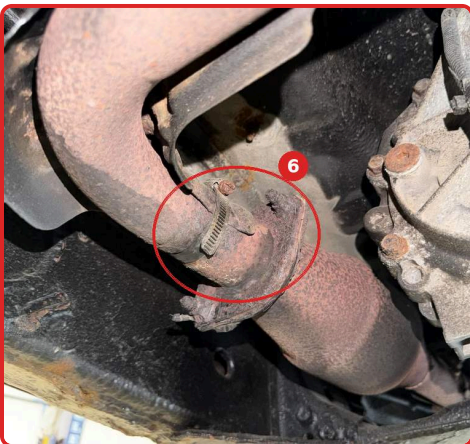
| Item | Status | Notes |
|---|---|---|
| Exhaust | Poor | Heavy rust on pipes and muffler, hanger severely corroded, flange near the catalytic converter deteriorated, heat shield held on with a hose clamp (#6). |

#6 Flange near the catalytic converter deteriorated; heat shield held with a hose clamp

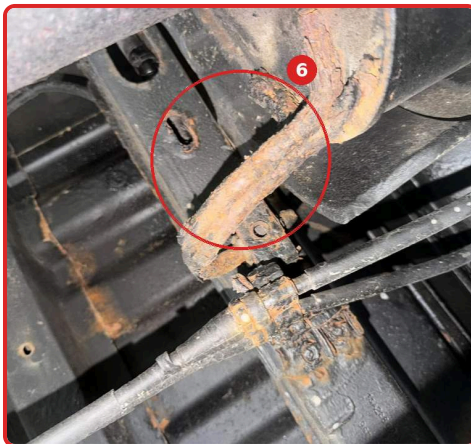
#6 Exhaust hanger and line brackets: severe corrosion

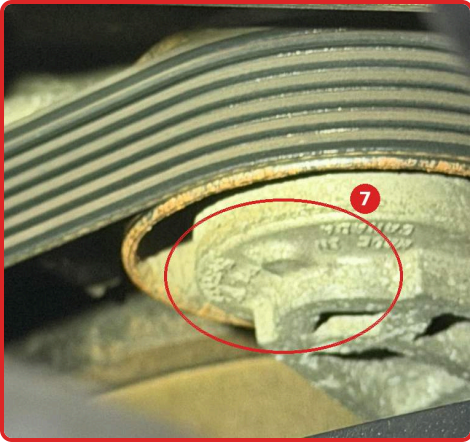
| Item | Status | Notes |
|---|---|---|
| Accessory drive | Attention | Belt tensioner and pulleys are rusted. Replace along with the belt (#7). |

#7 Belt tensioner / pulley: rust on the pulley

| Service | Priority | Interval / Notes |
|---|---|---|
| Drive belt / tensioner / pulleys | Attention | Replace as a set. |

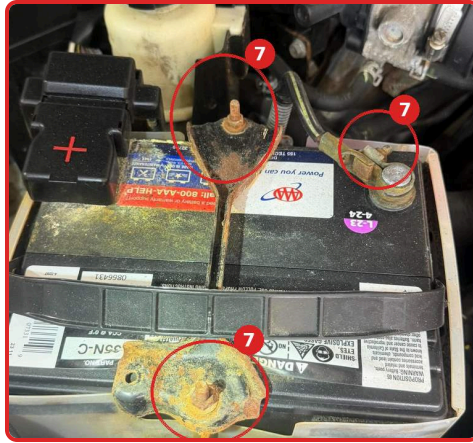
| Item | Status | Notes |
|---|---|---|
| Battery / charging | Attention | Battery dated 04/2024, charging normal. Hold-down heavily rusted and negative terminal corroded (#7). |

#7 Battery hold-down heavily rusted; negative terminal corroded

| Service | Priority | Interval / Notes |
|---|---|---|
| Battery | Good | Clean the terminals and replace the hold-down. |

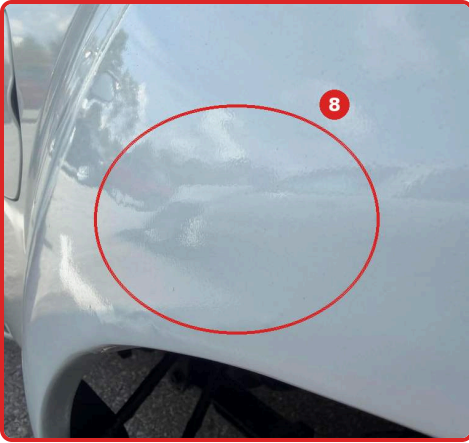
| Item | Status | Notes |
|---|---|---|
| Body panels / alignment | Attention | Panel gaps are even. Driver-side bed panel has waviness and a refinish texture (#8). |

#8 Driver-side bed panel: waviness consistent with prior repair and repaint

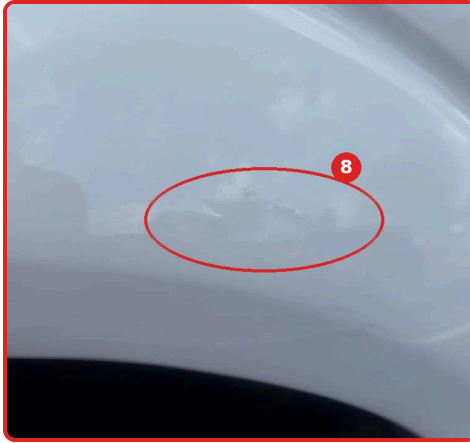
#8 Bed panel: paint texture change indicating refinish

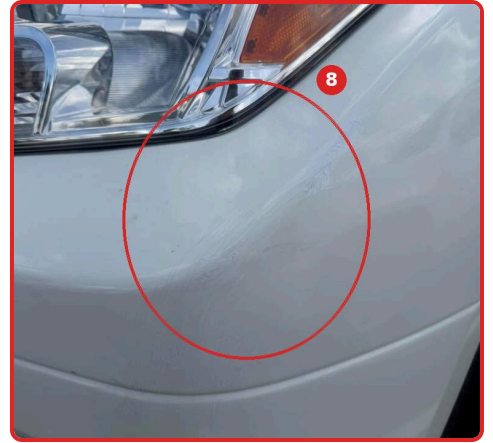
| Item | Status | Notes |
|---|---|---|
| Front bumper corner | Attention | Scuffing below the headlamp with brush touch-up paint (#8). |

#8 Front bumper corner: scuffing with brush touch-up paint

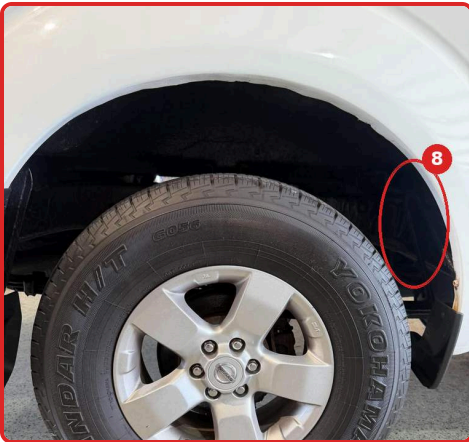
#8 Rear wheel arch lip: rust bubbling at the edge

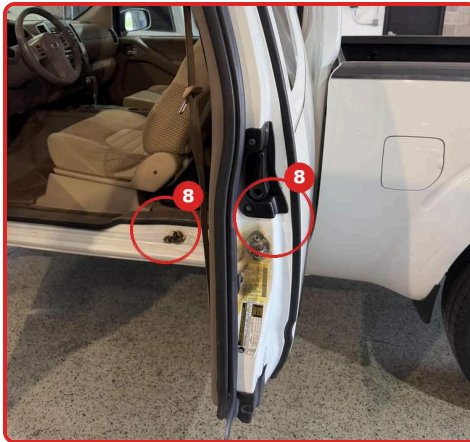
#8 Door sill and B-pillar: rust at fastener points

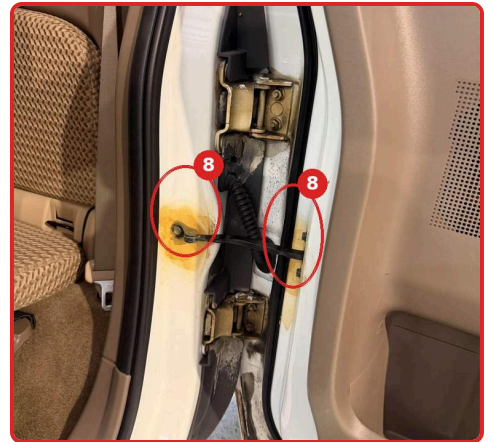
#8 Rear door hinge area: rust bleeding at the mounts

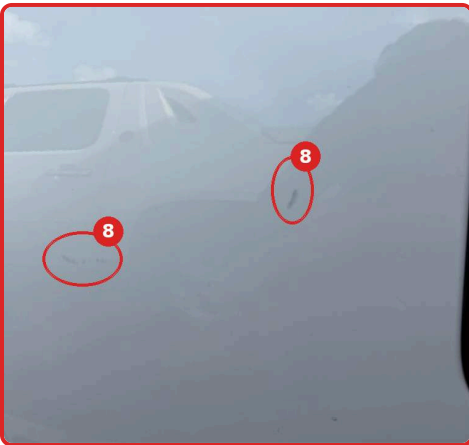
| Item | Status | Notes |
|---|---|---|
| Rear door | Attention | Light scuff marks (#8). |

#8 Rear door: light scuff marks

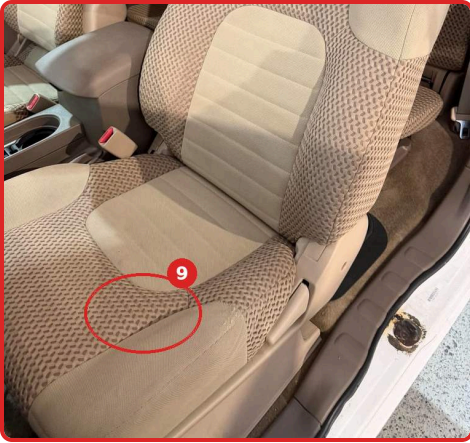
| Item | Status | Notes |
|---|---|---|
| Seats / upholstery | Attention | Clean cloth. Driver seat outer bolster is worn and frayed (#9). |

#9 Driver seat outer bolster worn and frayed

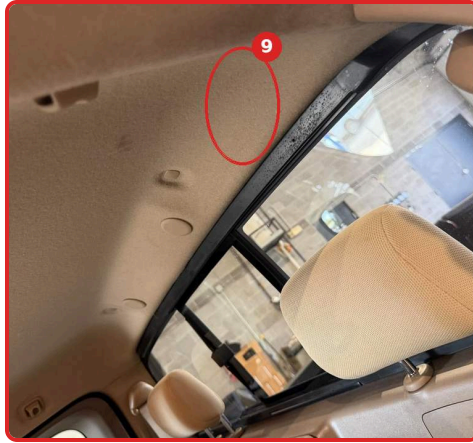
| Item | Status | Notes |
|---|---|---|
| Rear window seal | Attention | Dark spotting along the upper seal (#9). |

#9 Rear window seal: dark spotting along the upper seal
