# RIZQ VEHICLE INSPECTION

PRE-PURCHASE INSPECTION REPORT · 250-POINT INSPECTION

Report ID: **4415-TN**

| Year / Make / Model | 2013 Nissan Frontier | Body | King Cab, 6 ft Bed |

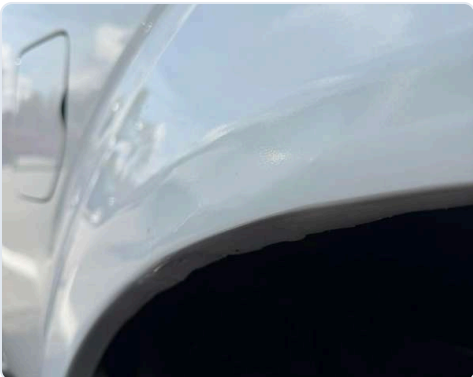
Bed side / wheel arch

| Item | Status | Notes |
|---|---|---|
| Rust: arch / door openings | Attention | Rust at the rear wheel arch lip, door sills, B-pillar and rear door hinge mounts (#8). |

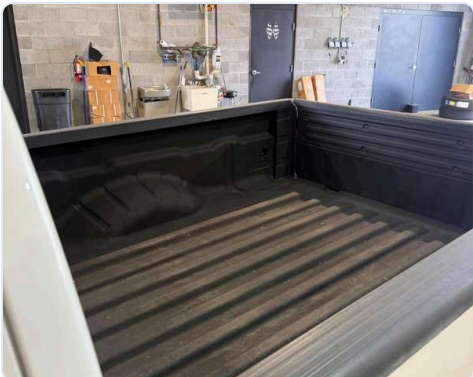
| Item | Status | Notes |
|---|---|---|
| Truck bed | Poor | Bed liner intact. Bed structure is rusted to the point it needs welded patch plates. |

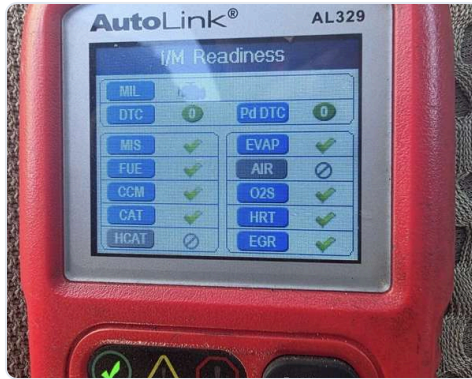
Scan: MIL off, 0 codes, monitors complete

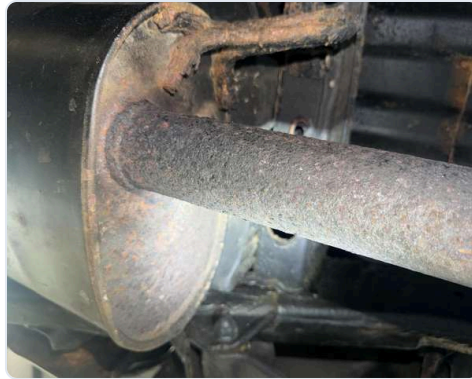
Muffler inlet

| Item | Status | Notes |
|---|---|---|
| Exhaust | Poor | Heavy rust on pipes and muffler, hanger severely corroded, flange near the catalytic converter deteriorated, heat shield held on with a hose clamp (#6). |

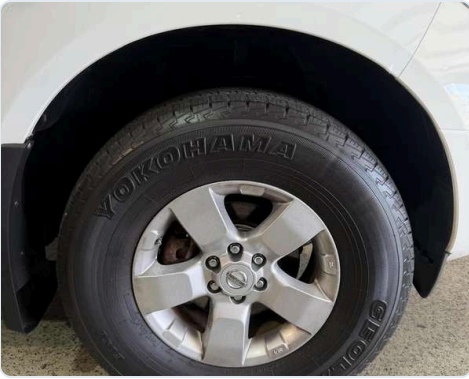
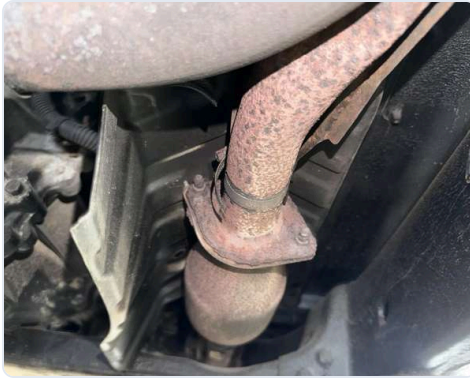
| Item | Status | Notes |
|---|---|---|
| Tire condition | Attention | Cracking is already showing in the tread and sidewalls. Plan replacement within 12 months. |
